UNITED STATES ENVIRONMENTAL PROTECTION AGENCY

SUBJECT: Inspection Report Transmittal to Ledgeview Farms, LLC

On April 9, 2015, EPA conducted an inspection of your facility, Ledgeview Farms in De Pere, Wisconsin. The purpose of the inspection was to evaluate compliance with the Clean Water Act (CWA) and Administrative Order V-W-13-AO-22. Ledgeview Farms is a large Concentrated Animal Feeding Operation (CAFO) as defined in 40 C.F.R. § 122. During the inspection, we observed violations of the CWA and Administrative Order. The CWA and Order requires you to immediately cease all unauthorized discharges.

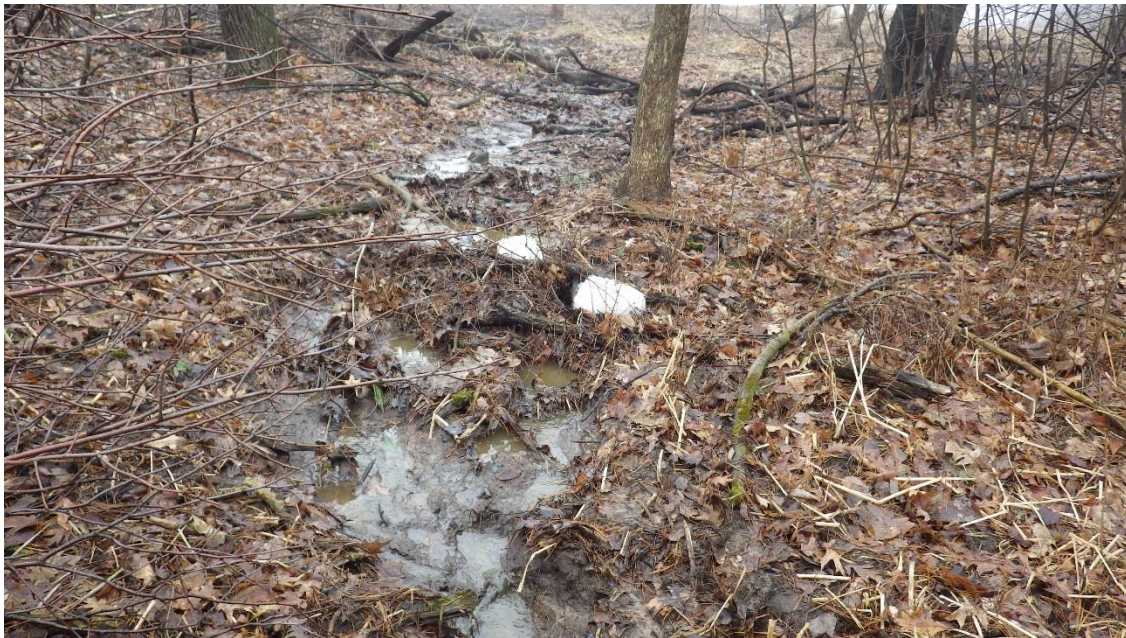
208: RIMG0217

Description: The drainage pathway flowed to the unnamed tributary.

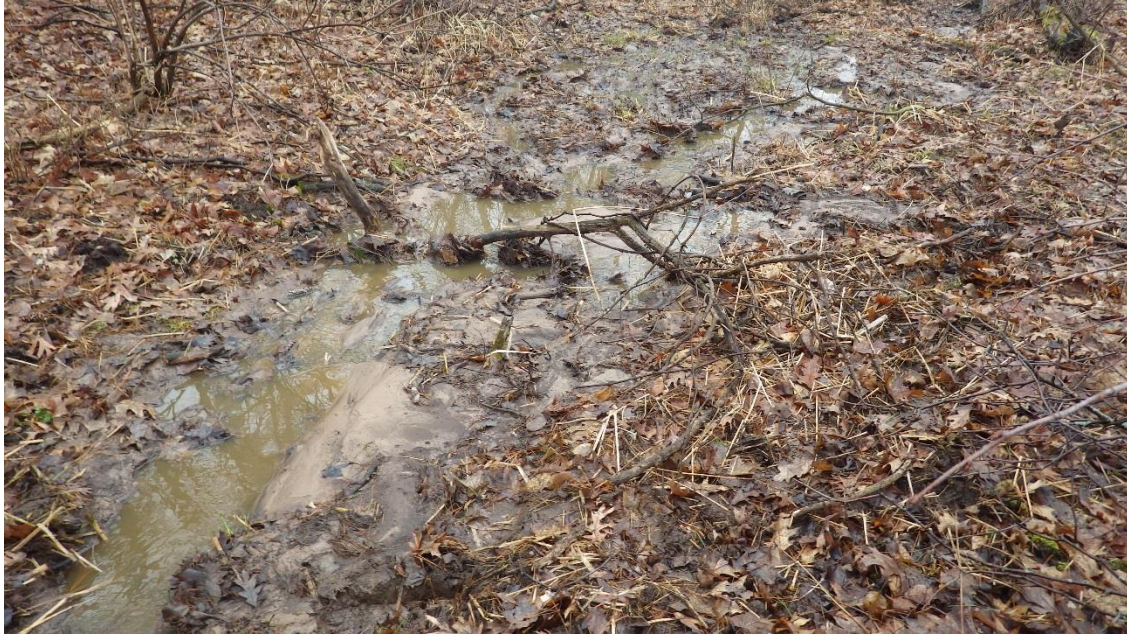
209: RIMG0218

Description: The drainage pathway flowed to the unnamed tributary.

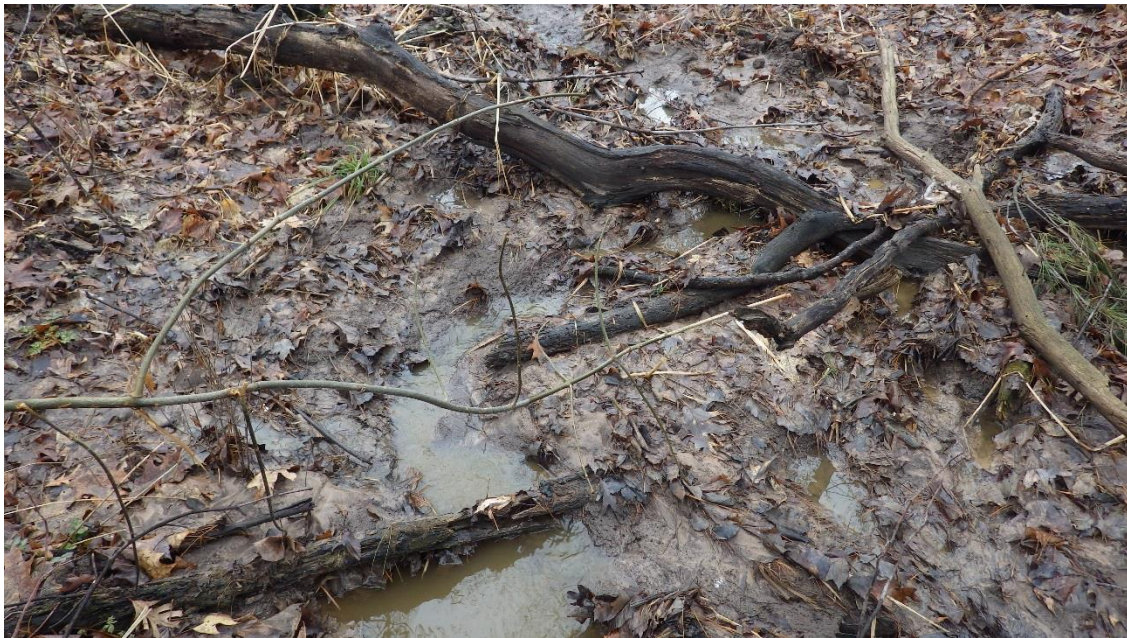
210: RIMG0219

Description: The drainage pathway flowed to the unnamed tributary.

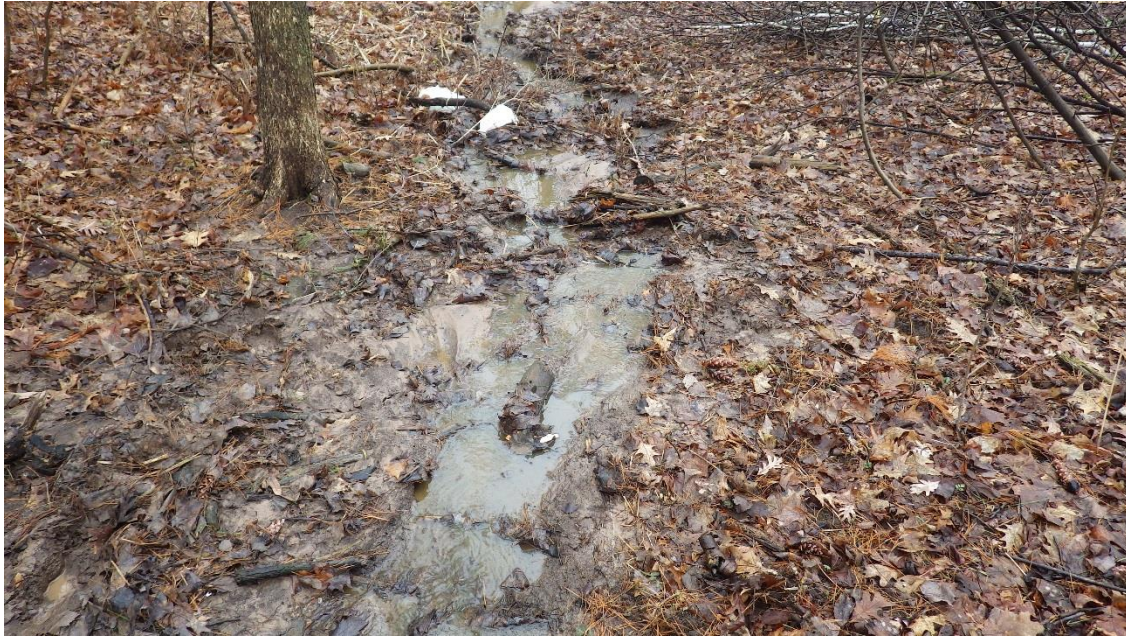
211: RIMG0220

Description: The drainage pathway flowed to the unnamed tributary.

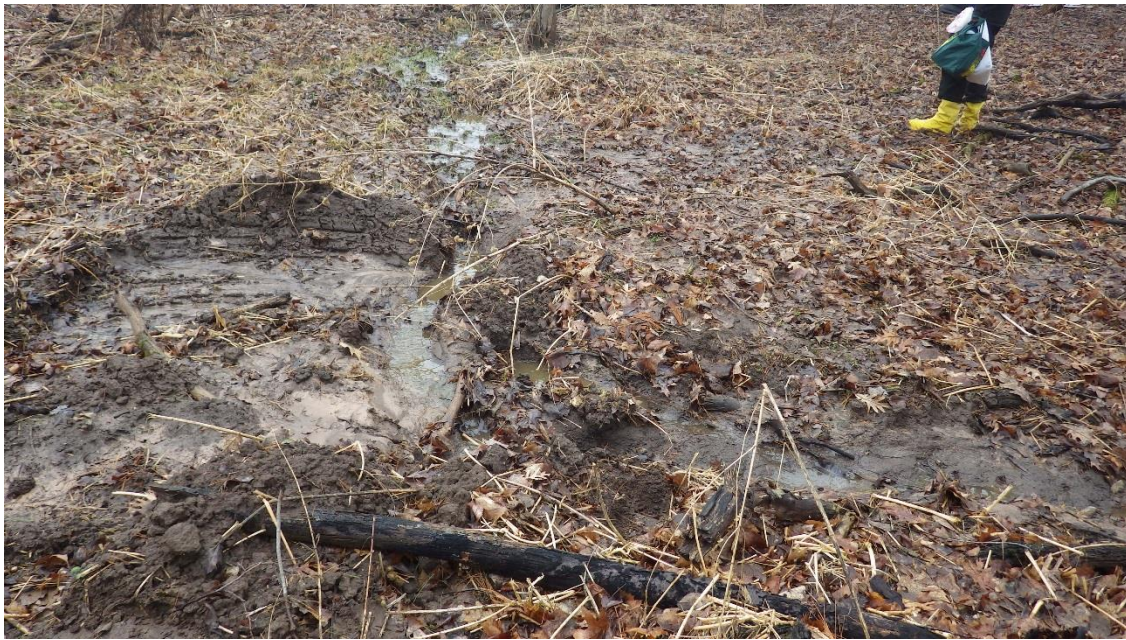
212: RIMG0221

Description: The drainage pathway flowed to the unnamed tributary.

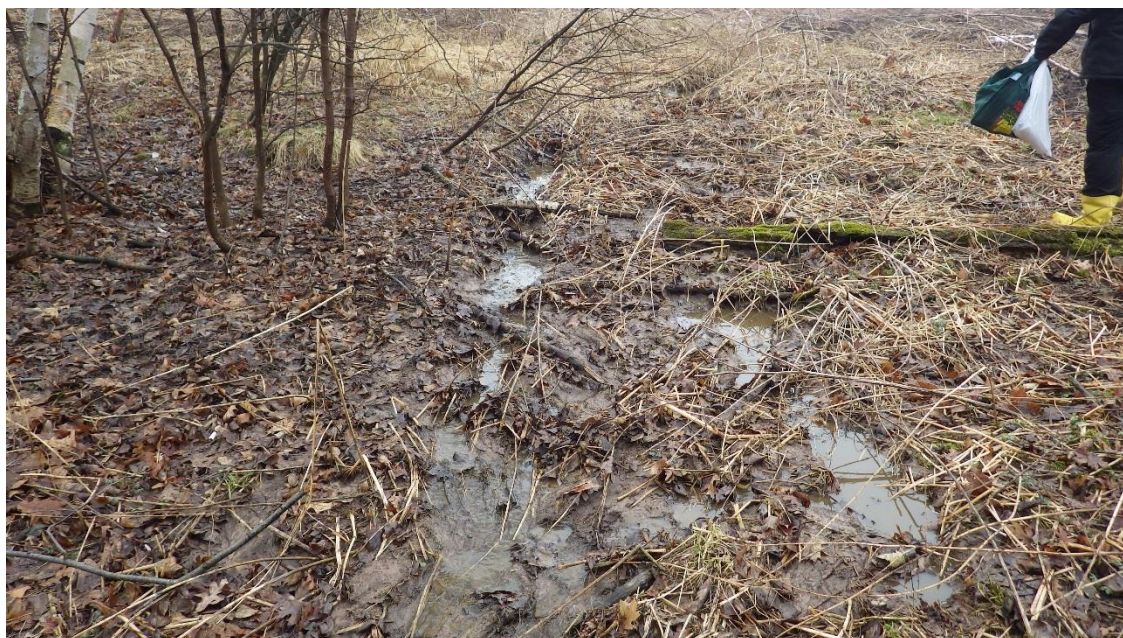
213: RIMG0222

Description: The drainage pathway flowed to the unnamed tributary.

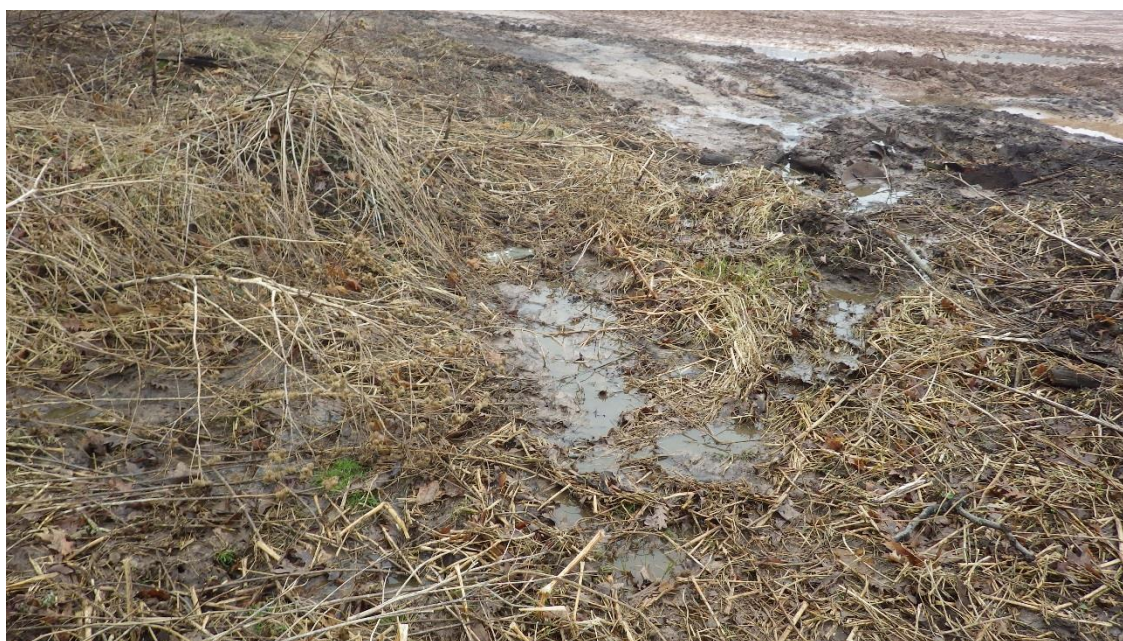
214: RIMG0223

Description: The drainage pathway flowed to the unnamed tributary.

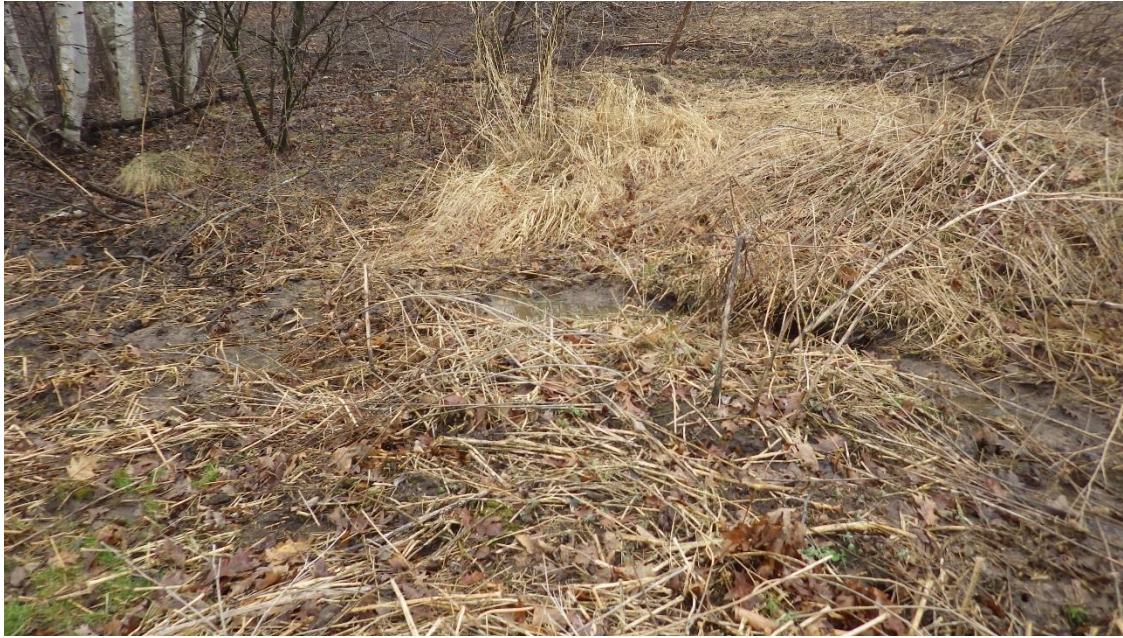
215: RIMG0224

Description: The drainage pathway flowed to the unnamed tributary.

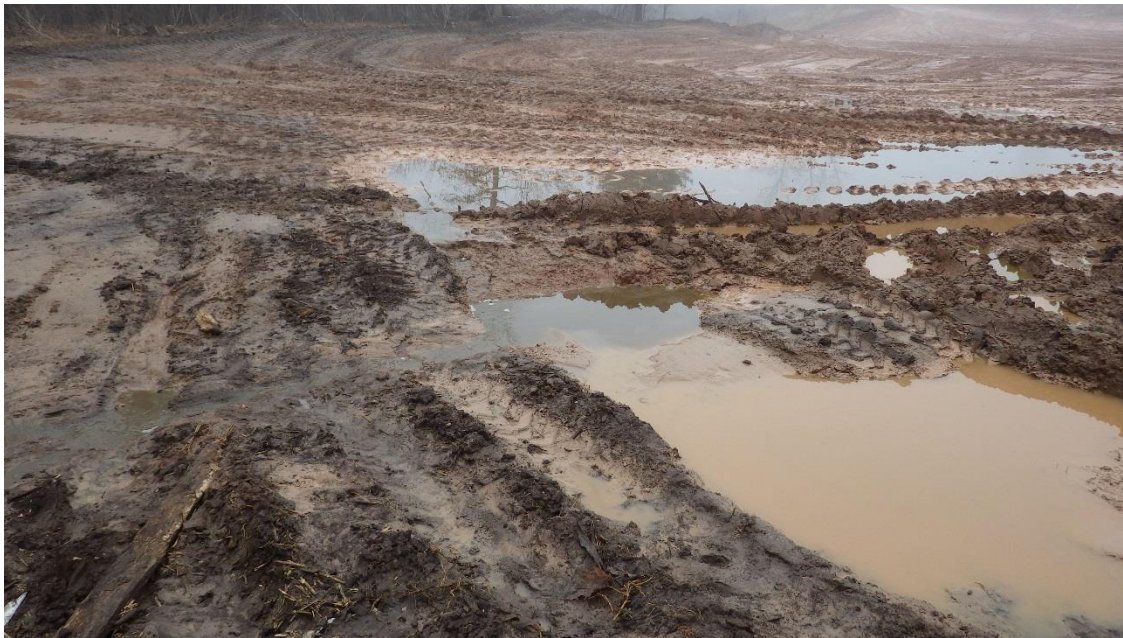
216: RIMG0225

Description: The drainage pathway flowed to the unnamed tributary.

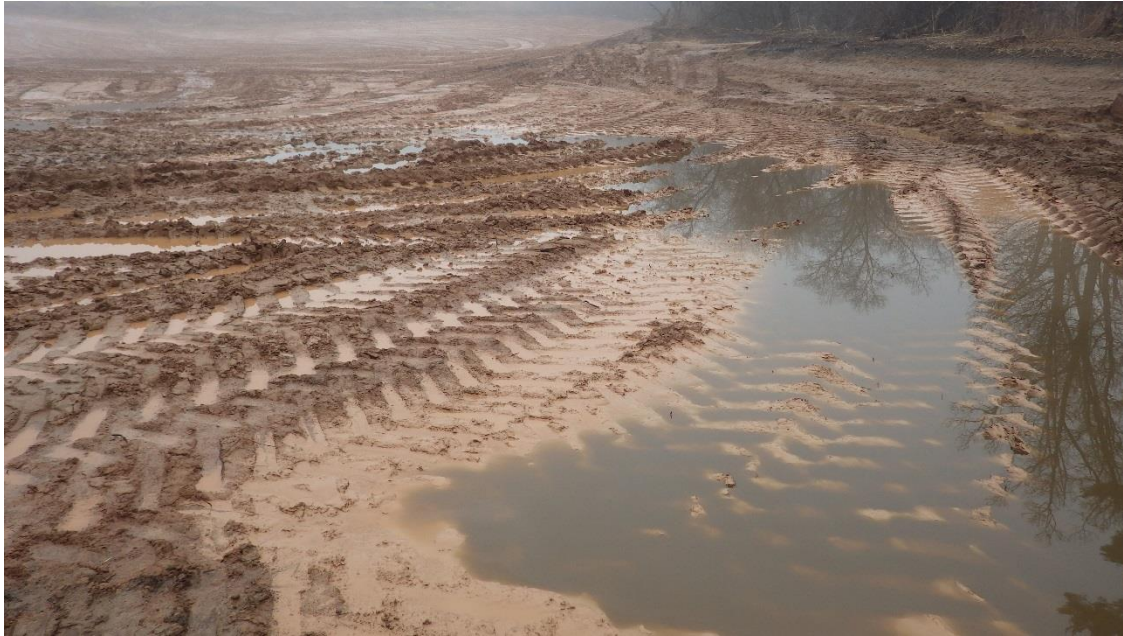
217: RIMG0226

Description: The drainage pathway flowed to the unnamed tributary.

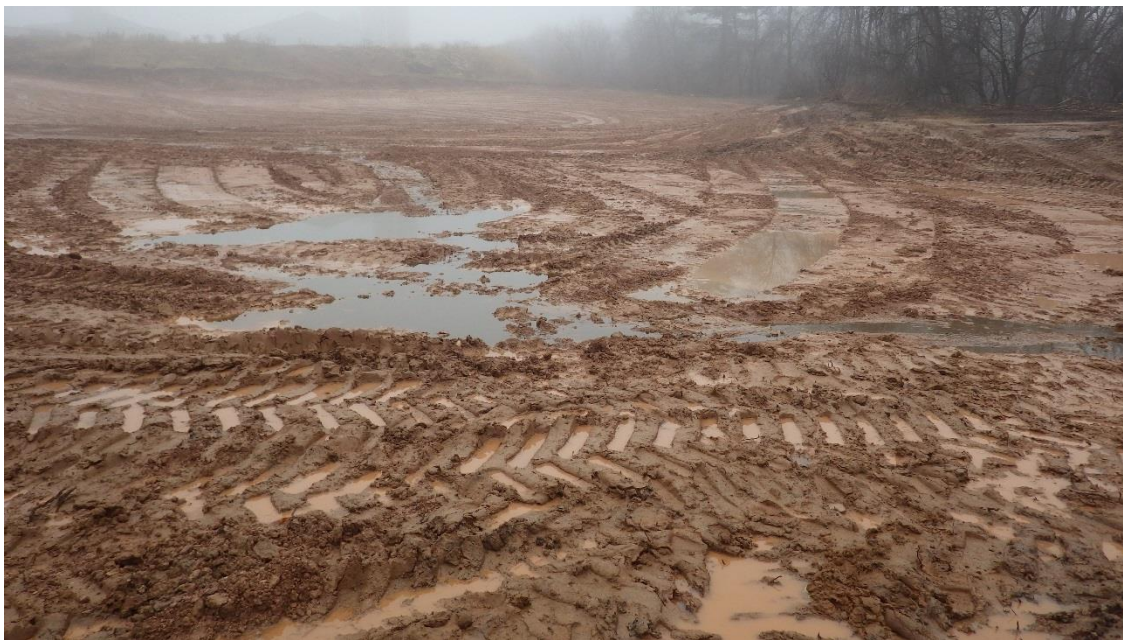
218: RIMG0227

Description: The drainage pathway flowed to the unnamed tributary.

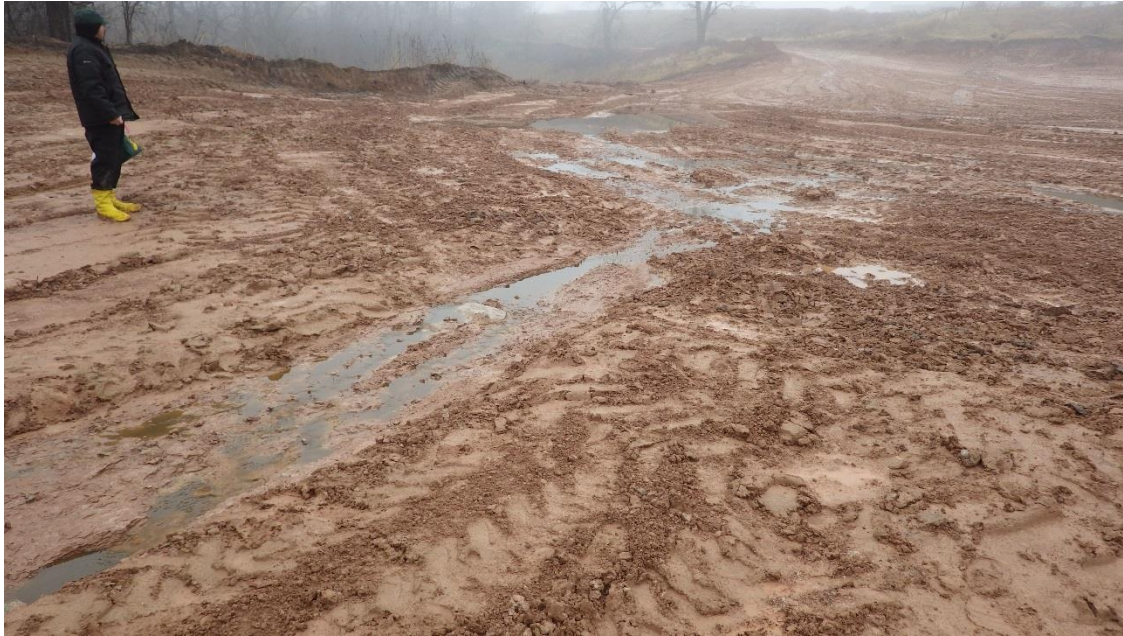
219: RIMG0228

Description: The drainage pathway flowed to the unnamed tributary.

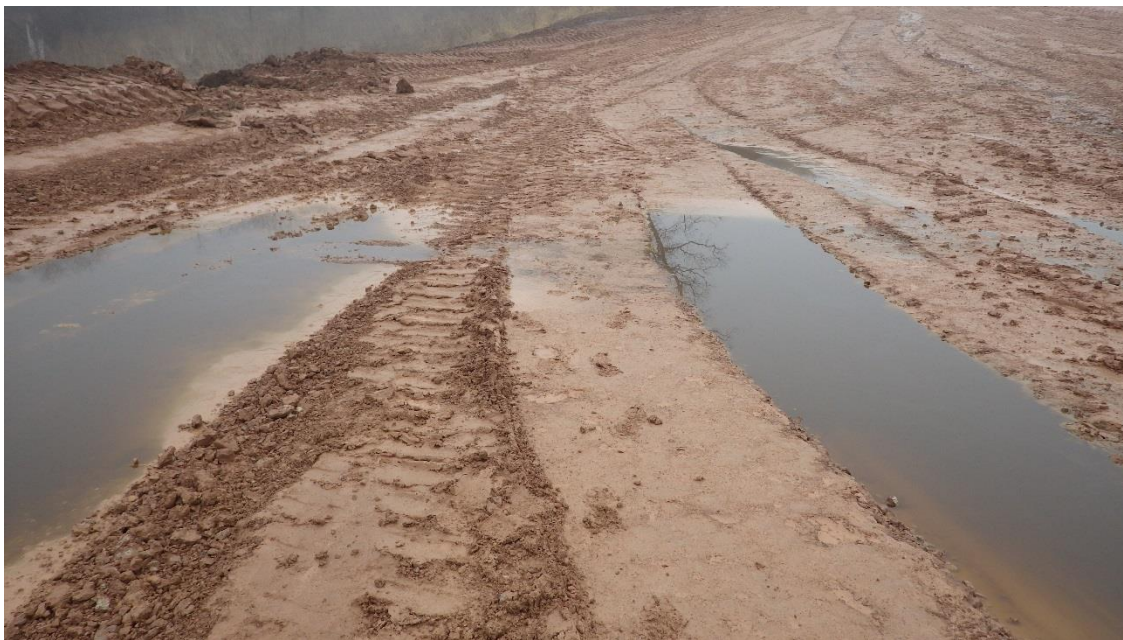
220: RIMG0229

Description: The drainage pathway flowed to the unnamed tributary.

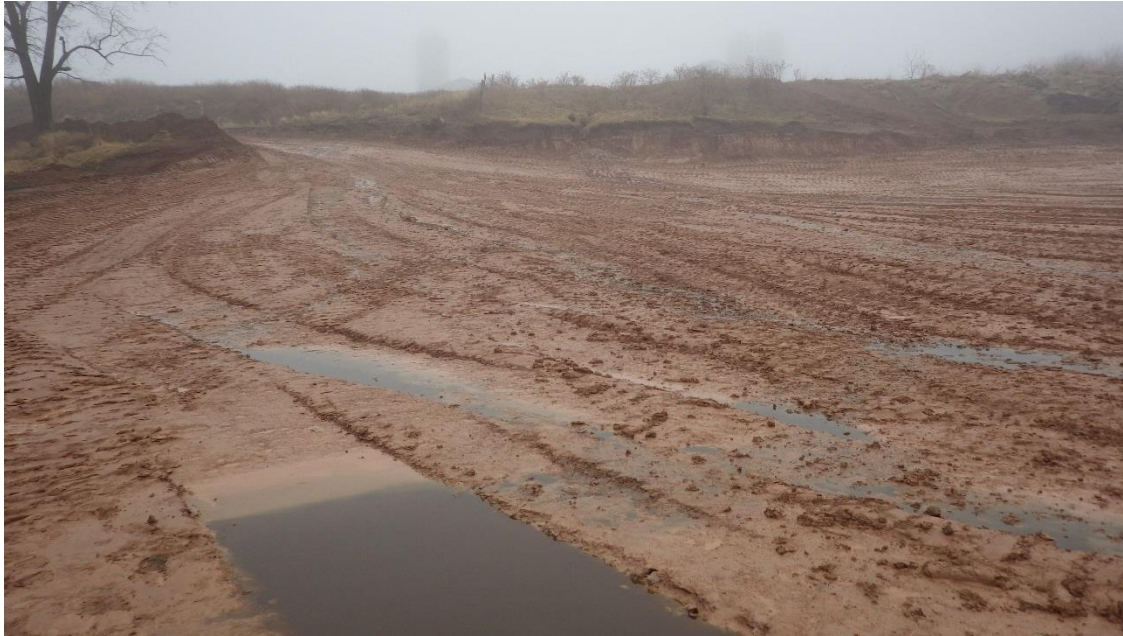
221: RIMG0230

Description: The drainage pathway flowed to the unnamed tributary.

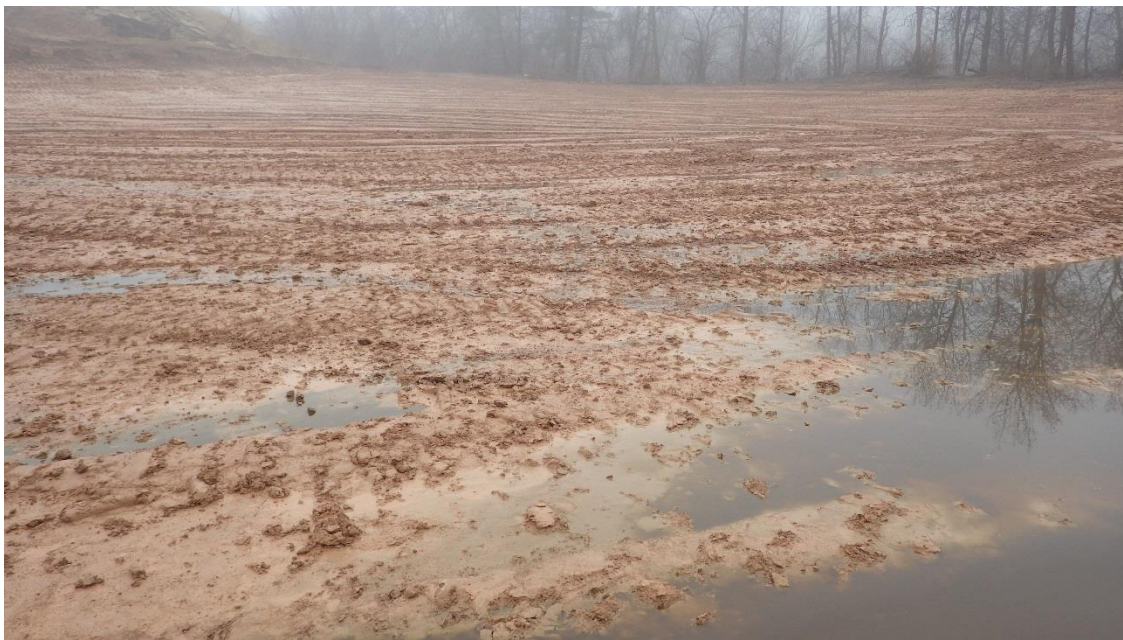
222: RIMG0231

Description: The drainage pathway flowed to the unnamed tributary.

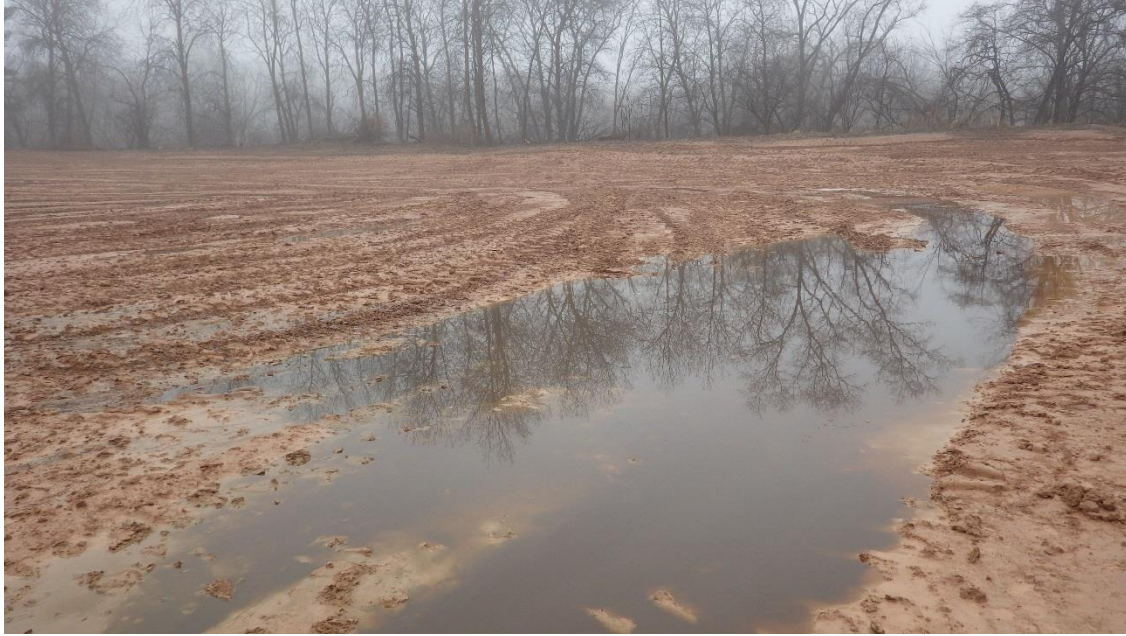
223: RIMG0232

Description: The drainage pathway flowed to the unnamed tributary.

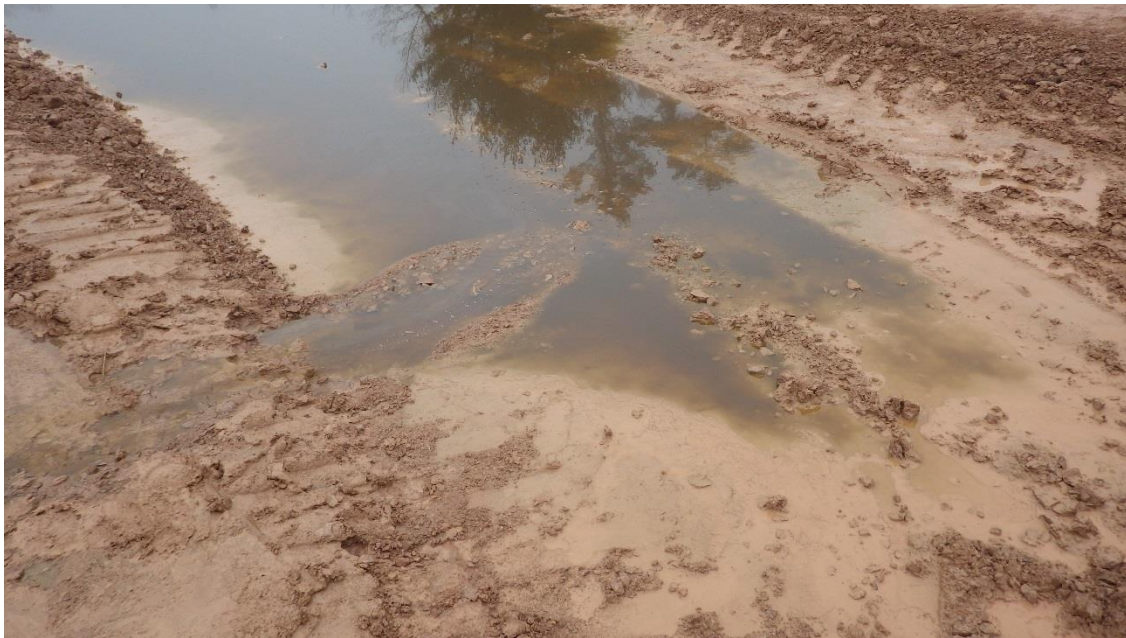
224: RIMG0233

Description: The drainage pathway flowed to the unnamed tributary.

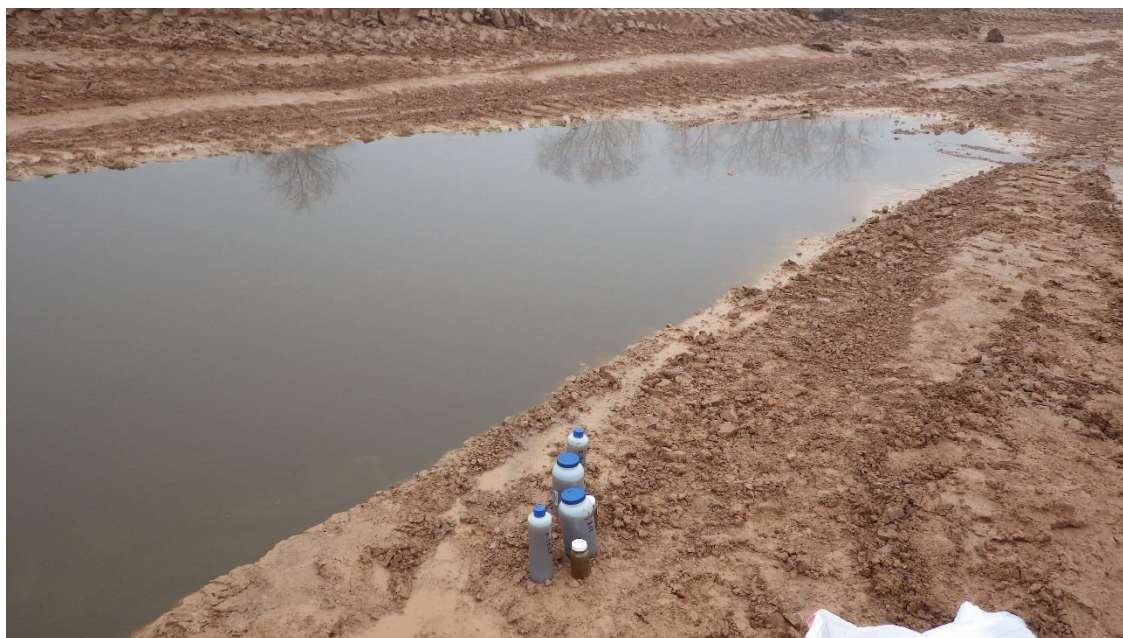
225: RIMG0234

Description: Sample S06 and S07 were taken at 1:00 p.m. from process wastewater in the drainage pathway in the borrow area that drains to the unnamed tributary on the east side of the Home site.

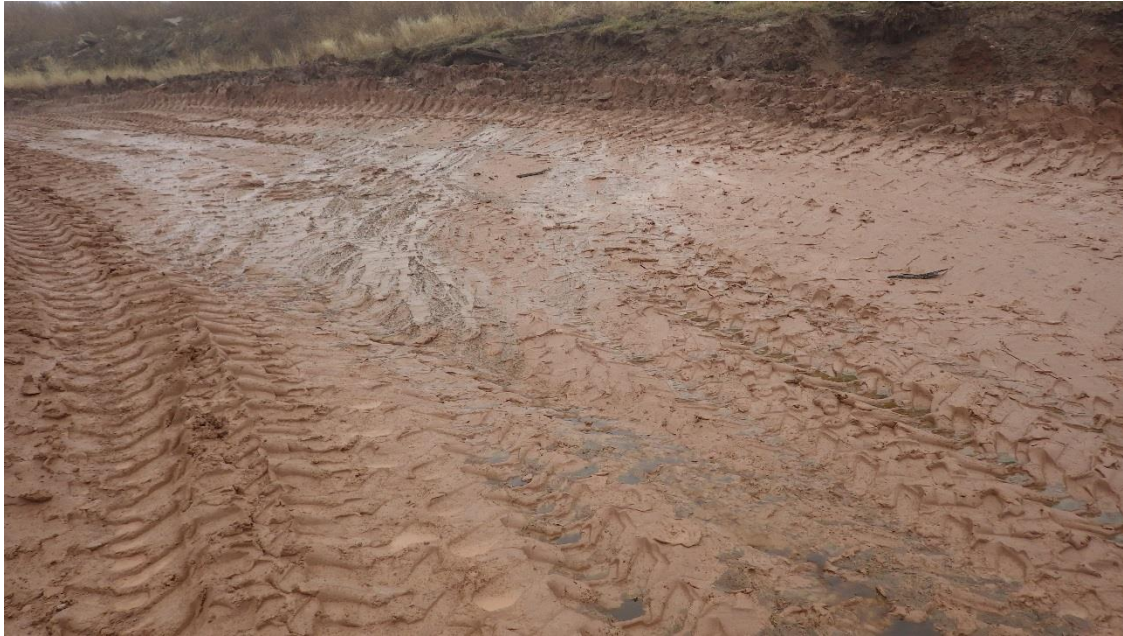
226: RIMG0235

Description: Sample S06 and S07 were taken at 1:00 p.m. from process wastewater in the drainage pathway in the borrow area that drains to the unnamed tributary on the east side of the Home site.

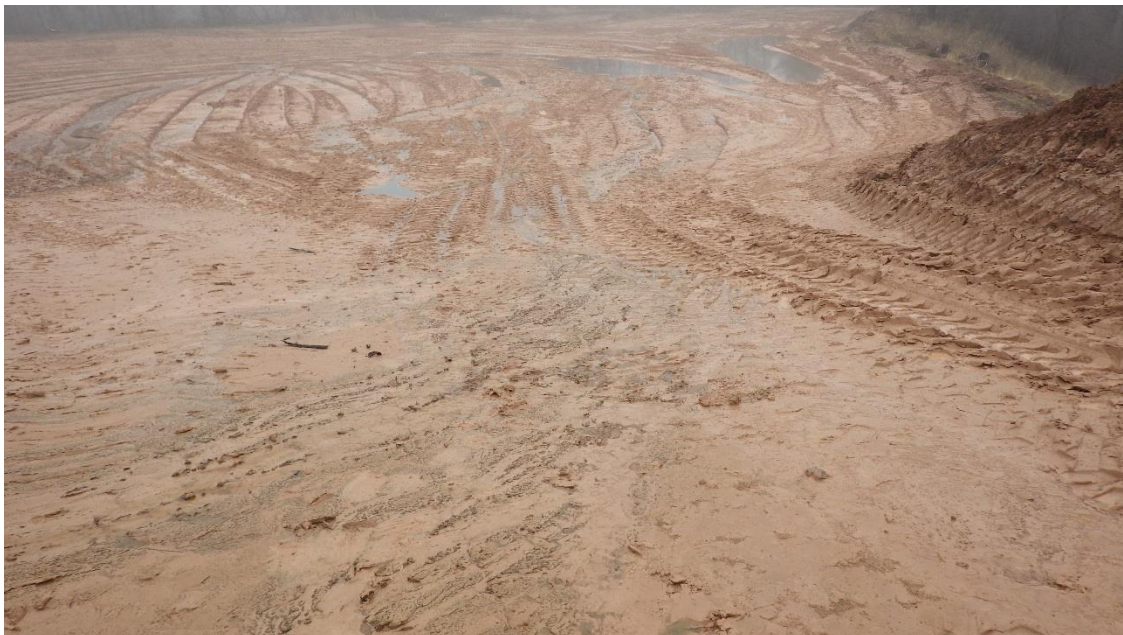
227: RIMG0236

Description: Manure and process wastewater flowed into the borrow area from the New Barn and cattle walkways between the New Barn and the barn west of the New Barn.

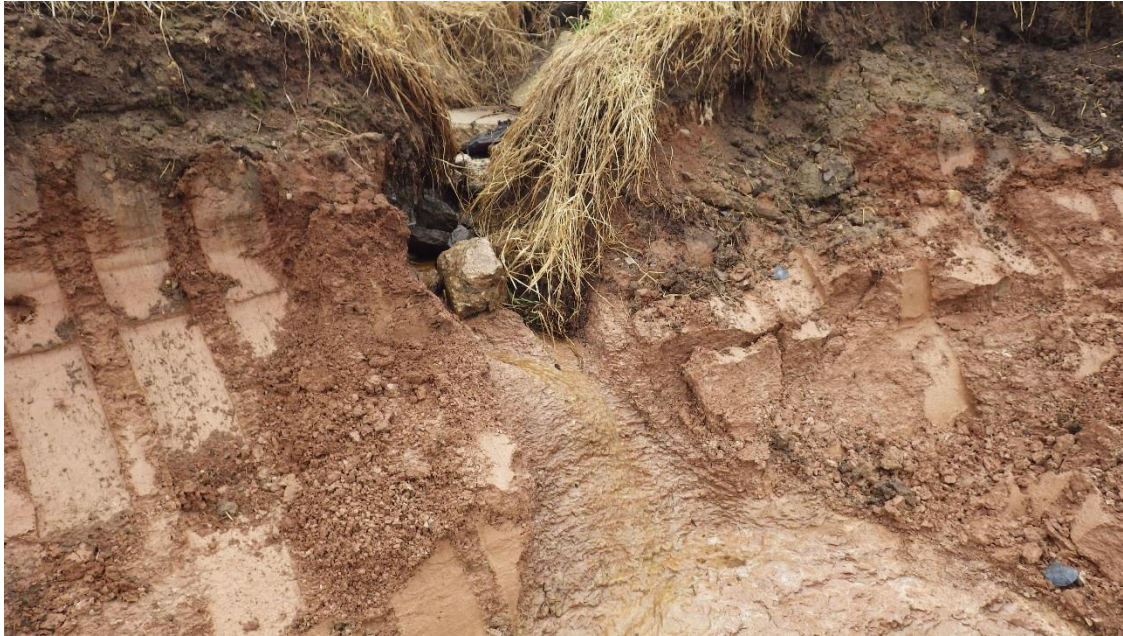
228: RIMG0237

Description: Manure and process wastewater flowed north through the borrow area from the New Barn and cattle walkways between the New Barn and the barn west of the New Barn.

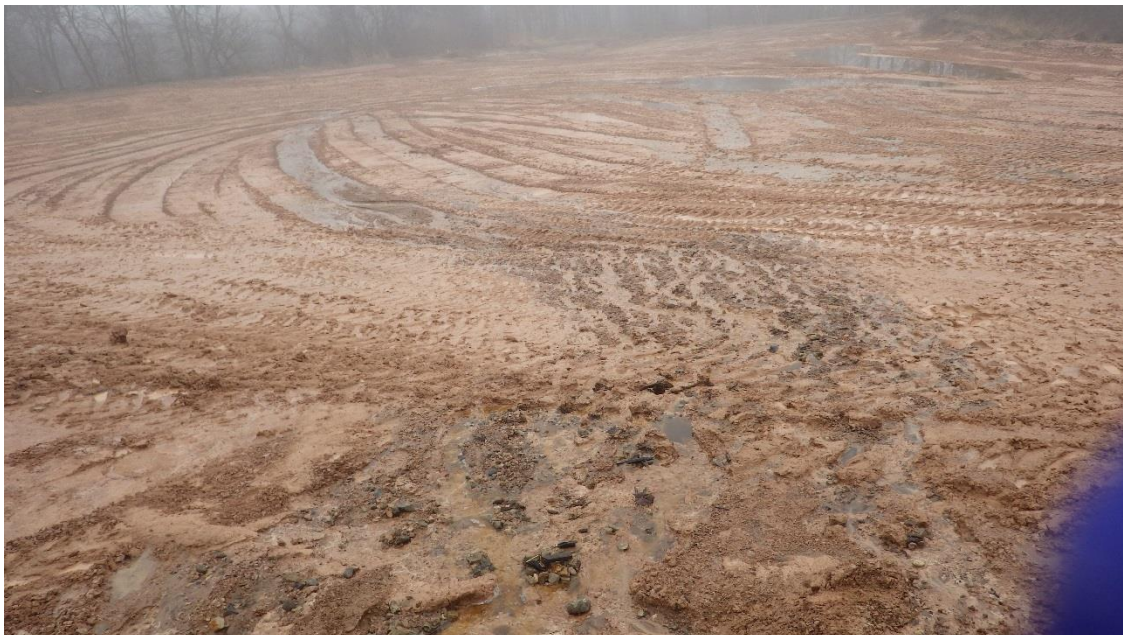
229: RIMG0238

Description: Manure and process wastewater flowed into the borrow area from the Milk Cow Barn and the access way between the Milk Cow Barn and the feed bunkers.

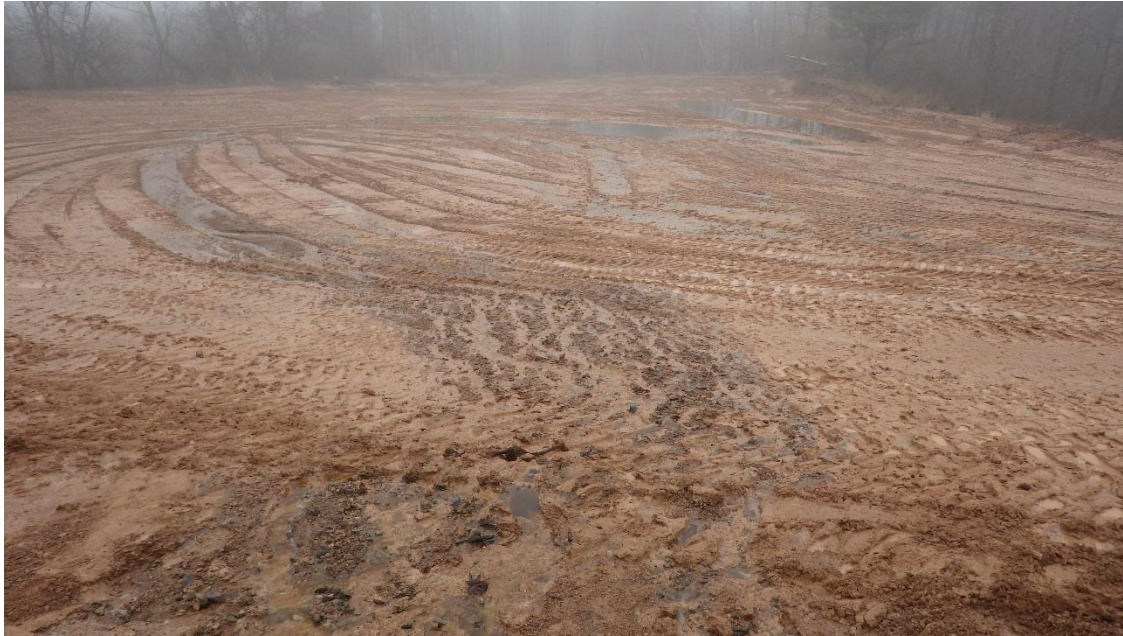
230: RIMG0239

Description: Manure and process wastewater flowed north through the borrow area from the Milk Cow Barn and the access way between the Milk Cow Barn and the feed bunkers.

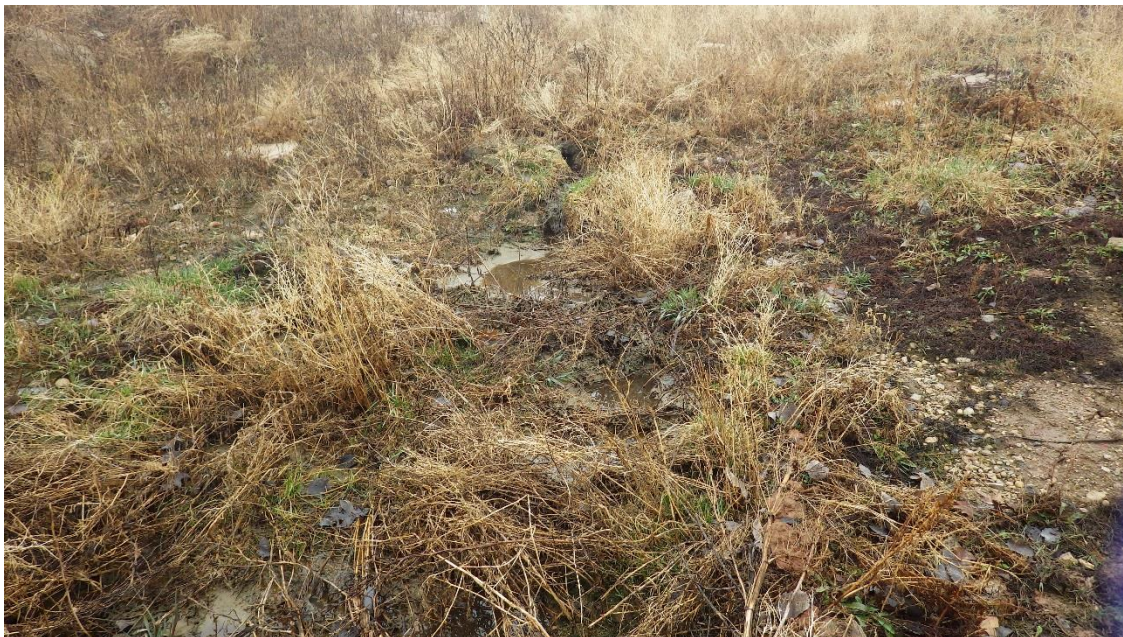
231: RIMG0240

Description: Manure and process wastewater flowed north through the borrow area from the Milk Cow Barn and the access way between the Milk Cow Barn and the feed bunkers.

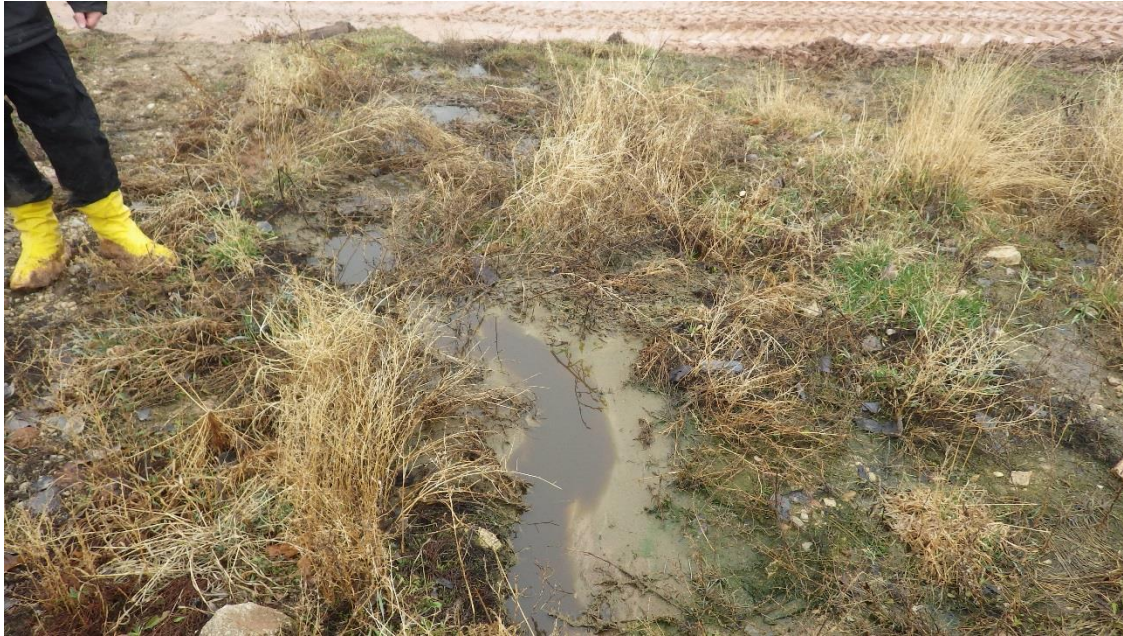
232: RIMG0241

Description: Manure and process wastewater flowed north toward the borrow area from the New Barn and cattle walkways between the New Barn and the barn west of the New Barn.

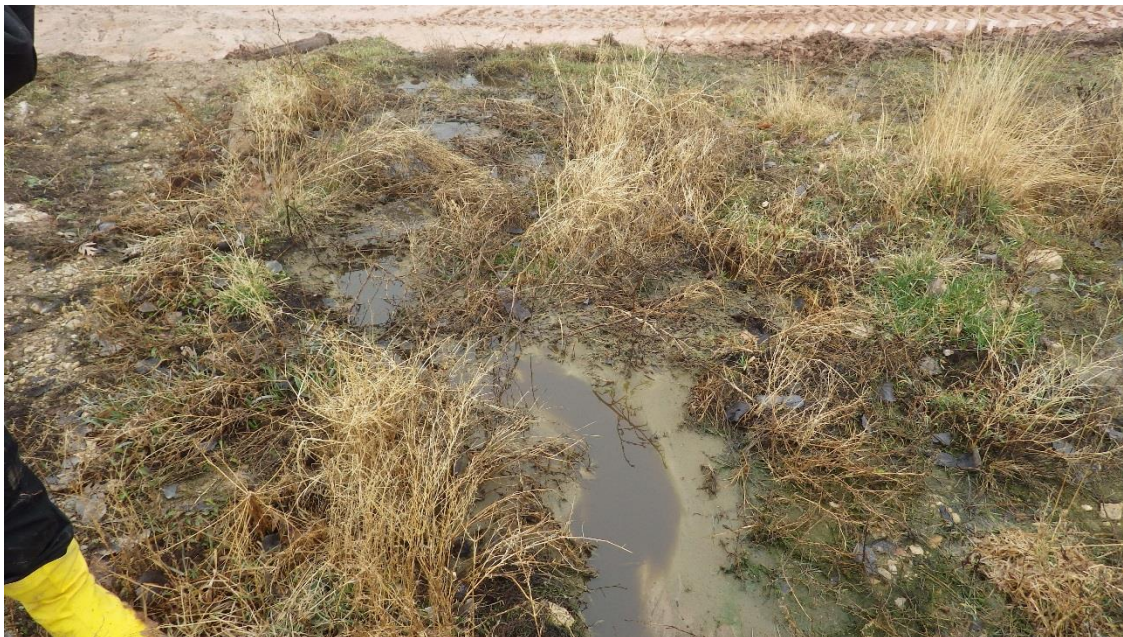
233: RIMG0242

Description: Manure and process wastewater flowed north toward the borrow area from the New Barn and cattle walkways between the New Barn and the barn west of the New Barn.

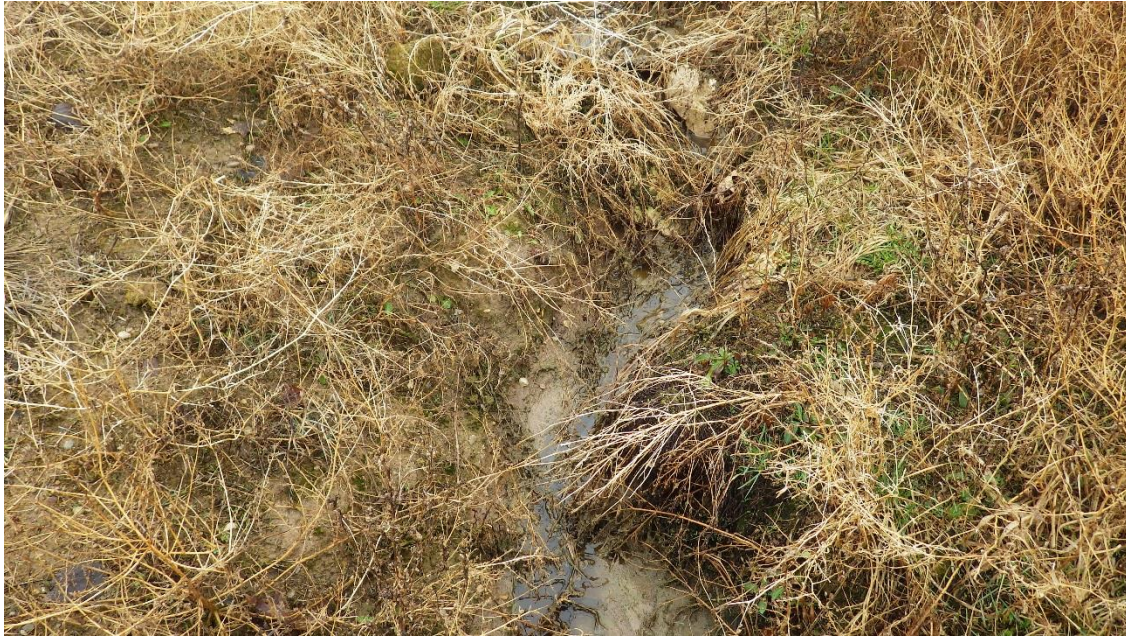
234: RIMG0243

Description: Manure and process wastewater flowed north toward the borrow area from the New Barn and cattle walkways between the New Barn and the barn west of the New Barn.

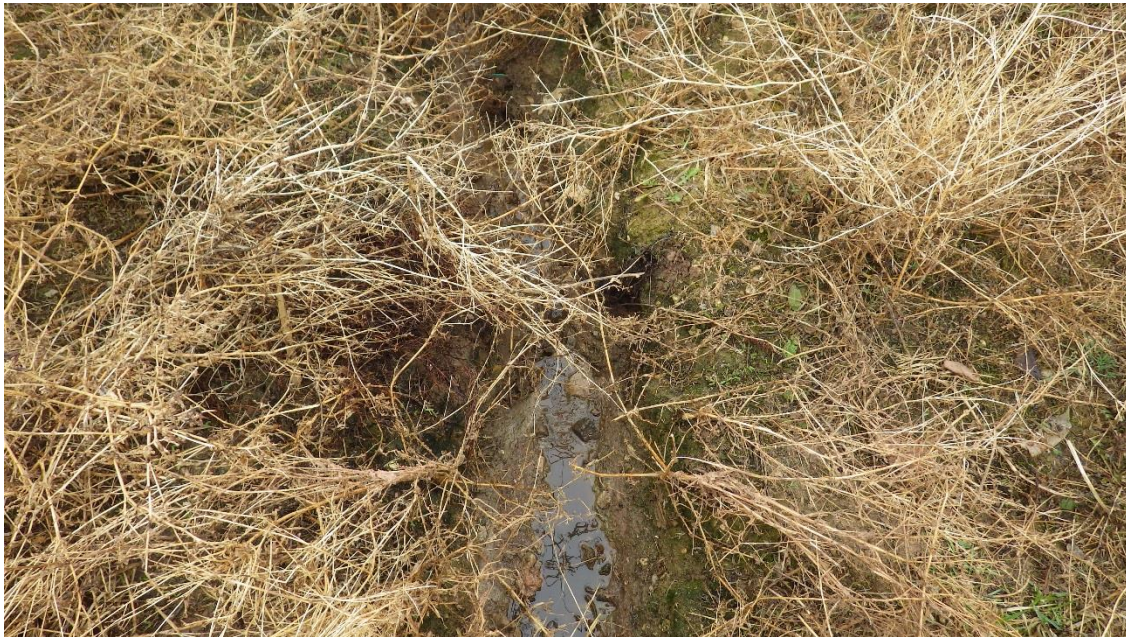
235: RIMG0244

Description: Manure and process wastewater flowed north toward the borrow area from the New Barn and cattle walkways between the New Barn and the barn west of the New Barn.

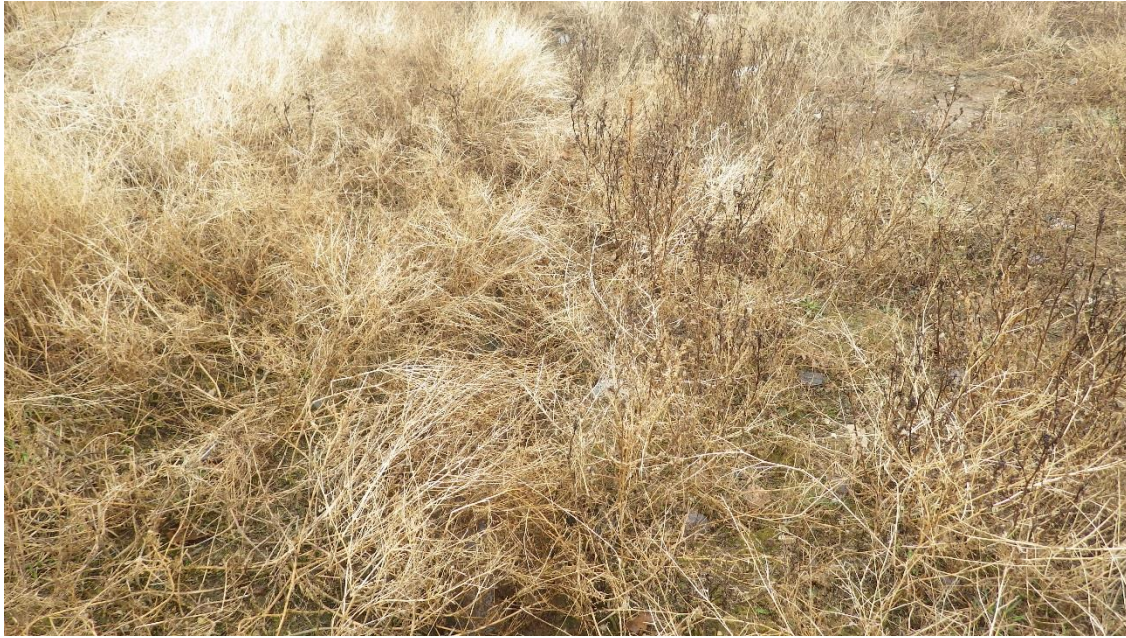
236: RIMG0245

Description: Manure and process wastewater flowed north toward the borrow area from the New Barn and cattle walkways between the New Barn and the barn west of the New Barn.

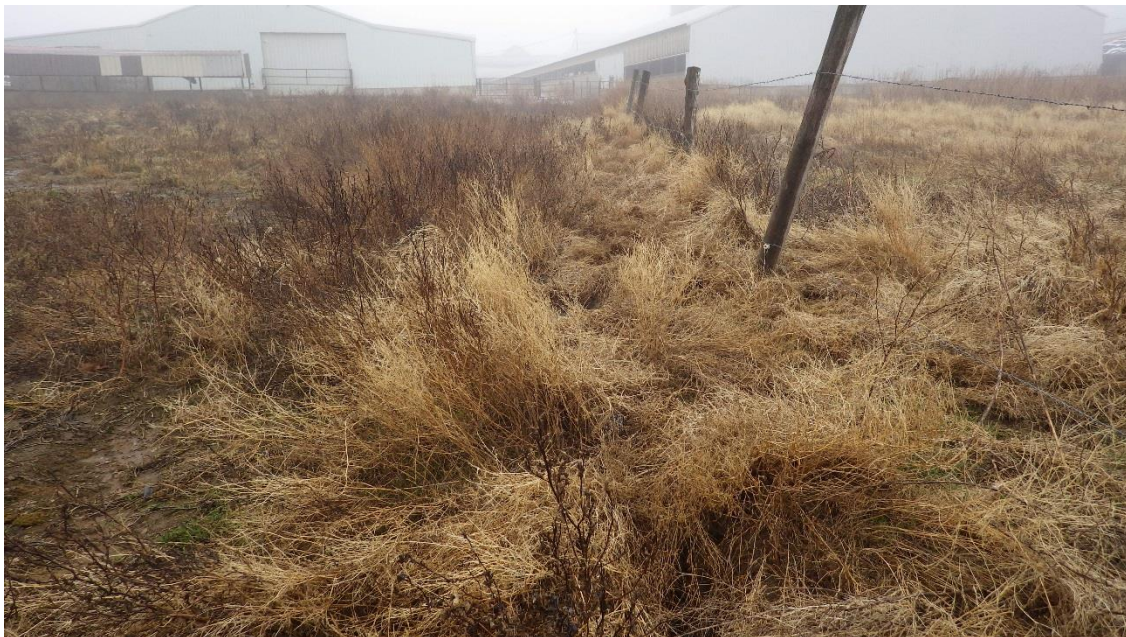
237: RIMG0246

Description: Manure and process wastewater flowed north toward the borrow area from the New Barn and cattle walkways between the New Barn and the barn west of the New Barn.
